PRODUCTION INVESTIGATION · TIMELINE · SolisCloud data 27 Jun – 21 Oct 2026

# Ban Doo Chiangrai: why solar production has not kept up with consumption

20 kWp PV · Solis 20 kW three-phase hybrid inverter, no battery · zero export (no sell-back to PEA) · small factory with a 57–62 kW machine · Ban Du, Chiang Rai

## Overheated electrical joints: fire, danger to life and the cost of heat

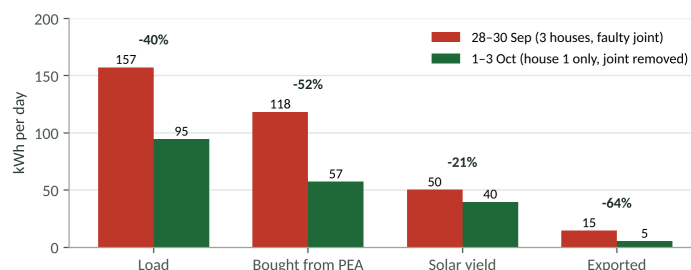
- **Energy turned into heat.** A hot joint draws paid-for energy that does no work. With the machine drawing about 82–97 A per phase, a badly corroded joint can waste around 400 W.
- **Higher load.** In the three days before the repair the site used 157 kWh/day and bought 118 kWh/day. In the three days after, it used 95 kWh/day and bought 57 kWh/day. Part of that drop is the machine running less, so the saving is indicative, not proven.
- **Disturbed measurement.** The meter and CT readings were disrupted around the fault, so the export control could not follow the real load.
- **Danger.** The damage was on the line side of the RCBO, so no breaker could detect it. Exposed live copper was a shock risk and the joint was at stage 3 of 5 on the path to fire.

Figure 4 – Three days before and three days after the faulty connection was removed (from the attached Research Report, section 7).

**What Solar ESS did.** The connection from house 1 to houses 2 and 3 was removed, and the site was rewired between 28 and 30 September with the phasing corrected. At house 2, Solar ESS relocated the connection to a new sub-circuit with its own breaker. For house 3, Solar ESS advised the local electrician how to connect it correctly. Since 1 October each of houses 2 and 3 runs on its own PEA supply, and the solar system supplies house 1 only.

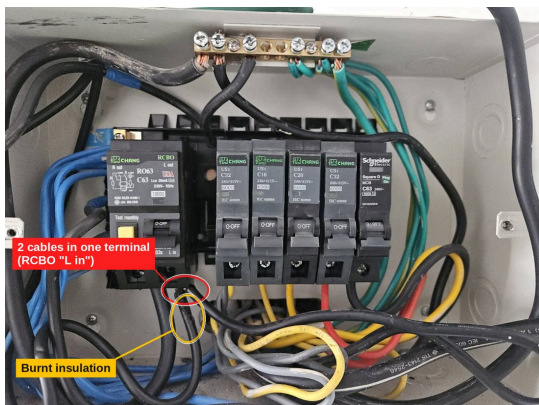
More than one cable, including a twisted bundle, is clamped in one RCBO terminal. The joint has overheated: insulation is melted and copper is corroded. A second board shows the same habit.

**The board.** The red circle marks the RCBO line-in terminal; the yellow outline marks scorched cable below it.

The damage runs down the cable from the terminal, which shows the heat started at the joint.

- ✓ **Inspect the RCBO terminal:** replace the RCBO if the terminal or body is discoloured, pitted or melted.
- ✓ **One conductor per terminal:** unless the maker states that the terminal accepts more.

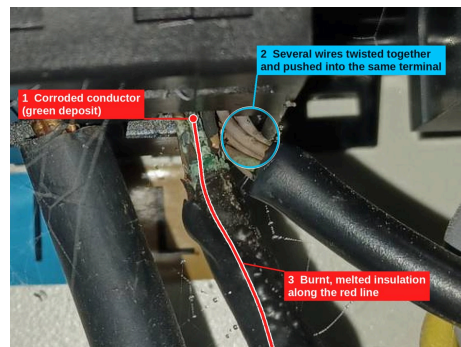
**The terminal, enlarged.** The numbers match the findings below.

### 1 Corroded conductor

Green deposit on the copper where it enters the terminal: a sign of heat, moisture and acid from overheated PVC.

### 2 Several wires in one terminal

Separate wires twisted into a bundle and forced in beside the main cable. The screw cannot grip them evenly.

### 3 Burnt, melted insulation

Melted insulation, green copper. **This site.**

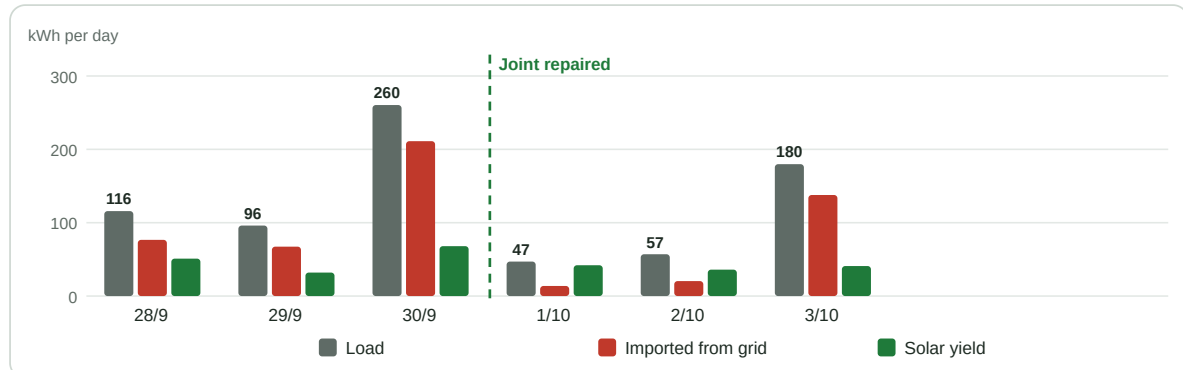
Comparing three days each side of the repair, average load fell from 157 to 95 kWh a day and grid import from 118 to 57 kWh a day: about 287 THB a day at 4.7 THB/kWh.
