PRODUCTION INVESTIGATION · TIMELINE · SolisCloud data 27 Jun – 21 Oct 2026

# Ban Doo Chiangrai: why solar production has not kept up with consumption

20 kWp PV · Solis 20 kW three-phase hybrid inverter, no battery · zero export (no sell-back to PEA) · small factory with a 57–62 kW machine · Ban Du, Chiang Rai

## Overheated electrical joints: fire, danger to life and the cost of heat

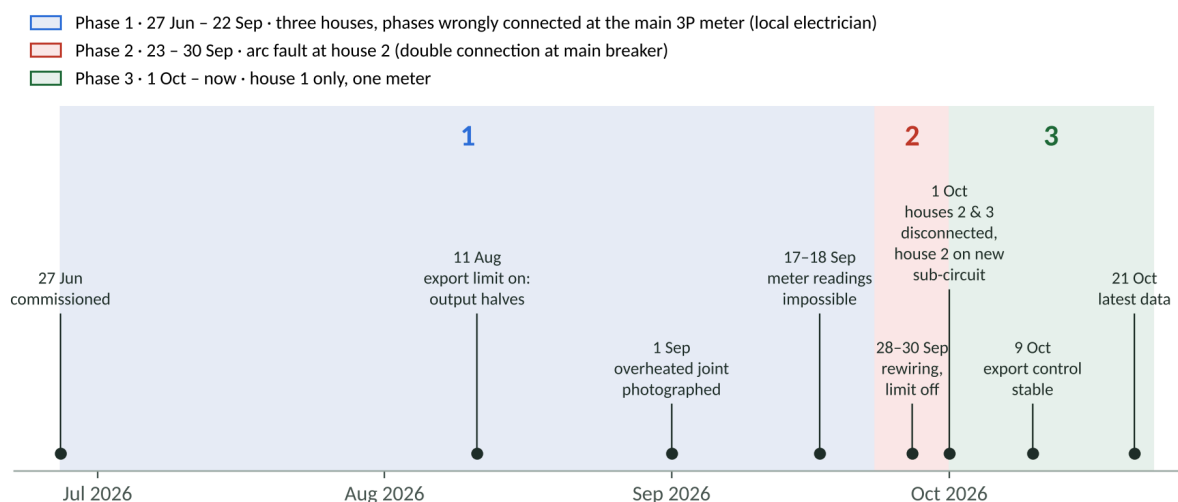
Figure 1 – Timeline of the plant from commissioning to 21 October 2026.

Since commissioning on 27 June the panels and inverter have worked normally. Production has fallen short of consumption for three different reasons, one after the other:

- 27 Jun – 22 Sep · Three houses on one system, phases wrongly connected at the main three-phase meter by a local electrician.** The meter and CT saw the machine's load on the wrong phases, so the export control worked on false readings and output was held down.

- 23 – 30 Sep · Arc fault at the connection to house 2.** The supply from house 1 to houses 2 and 3 was double-connected at each house at the main breaker that also feeds the 1st floor to the 2nd floor. The overloaded joint overheated, wasted energy as heat, disturbed the meter readings and created a fire and shock hazard, so the connection had to be removed.

- 1 Oct – now · House 1 only, one meter.** The readings are now correct, but the base load is small and unbalanced (67% on L1), while the 57–62 kW machine runs only on Wednesdays and Saturdays, mostly outside sun hours. Zero export therefore curtails about half the available solar.

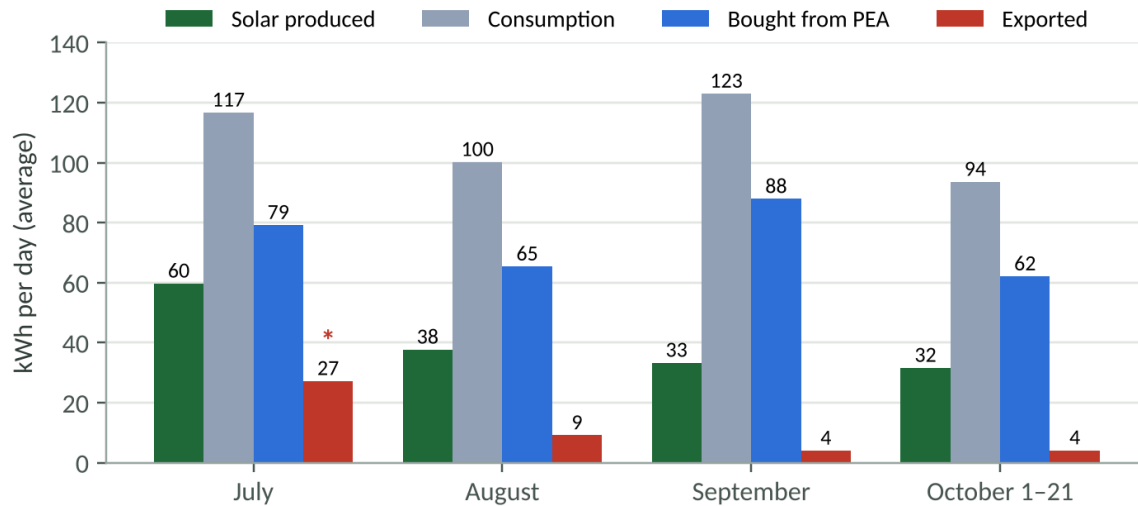
Figure 2 – Daily averages per month. \* July export is overstated: with the phases swapped, part of the machine load was recorded as export. September purchases exclude the impossible readings of 17–18 September.

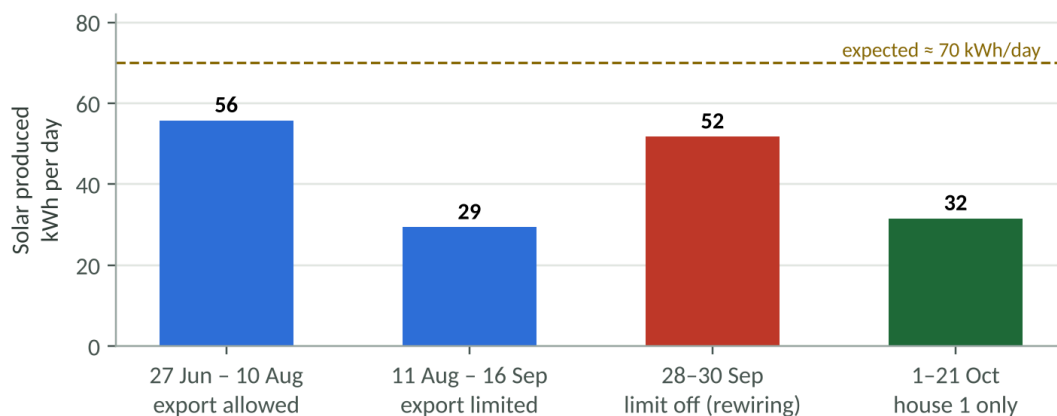
Figure 3 – Average solar production in each period against the ≈ 70 kWh/day the array can make. Only the days with no export limit (before 11 Aug, and 28–30 Sep during rewiring) came close.

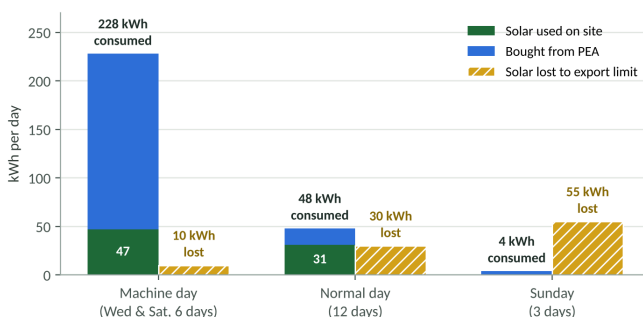
Figure 5 – Energy per day by day type, 1–21 Oct.

- **Working hours after sunset.** The load curve for 20 October shows the pattern clearly: the site starts around 09:30, dips at lunch, then keeps drawing about 5–7 kW from 17:30 until about 21:00 – after sunset (17:53), when all of it comes from PEA, roughly 20 kWh that evening – while solar from about 07:30 to 09:30 goes unused.

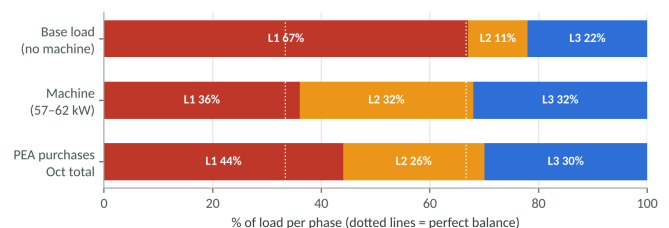
Figure 6 – Share of load per phase, October.

- **Phase imbalance.** The base load sits 67% on L1, 11% on L2 and 22% on L3. The hybrid inverter can supply each phase separately, so this does not cut production, but it overloads L1 and the neutral (about 13 A) – the same path that failed in September. **Solar ESS detected this heavy imbalance and has reported it to the factory's electrician.**

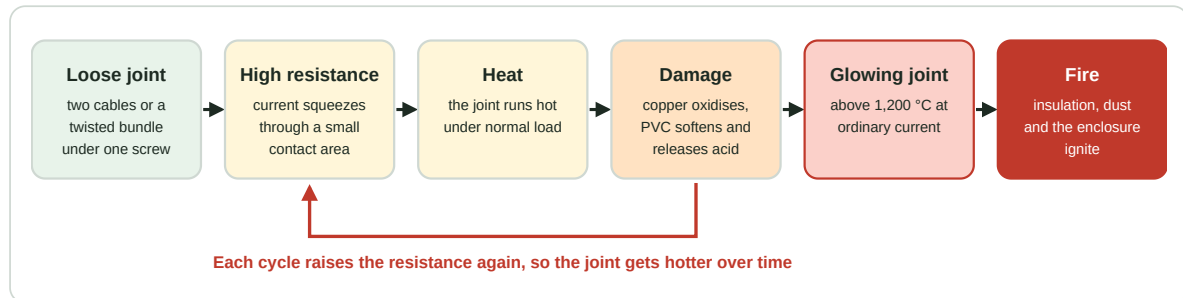
## 2 The mechanism: how a loose terminal becomes a fire

### Why several wires under one screw are loose

The screw bears on the outer strands only. Inner wires sit slack, and every heating and cooling cycle lets the bundle settle further. A twisted joint is also several circuits drawing current through one point.

An MCB reacts to too much current and an RCBO to current leaking to earth. A hot joint causes neither: tests show it wastes only about 5 to 50 W, with normal load current flowing. The protection sees nothing wrong.

Overheated PVC releases hydrogen chloride. With moisture it forms acid that turns copper into green copper salts. The deposit conducts poorly, which raises the resistance again.
